Lenord & Bauer Gel 823XXX

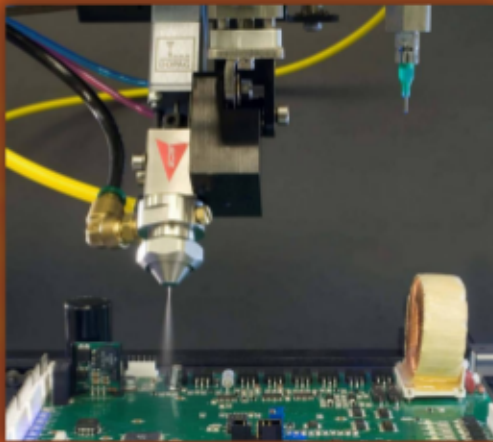
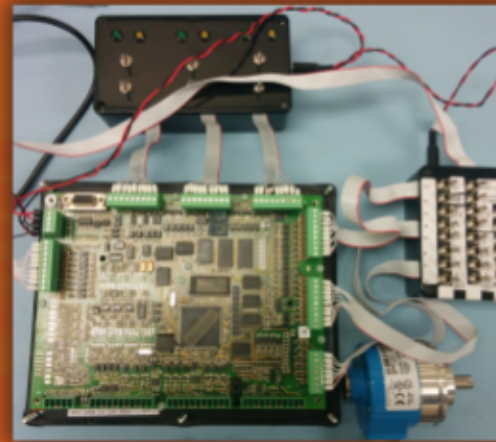
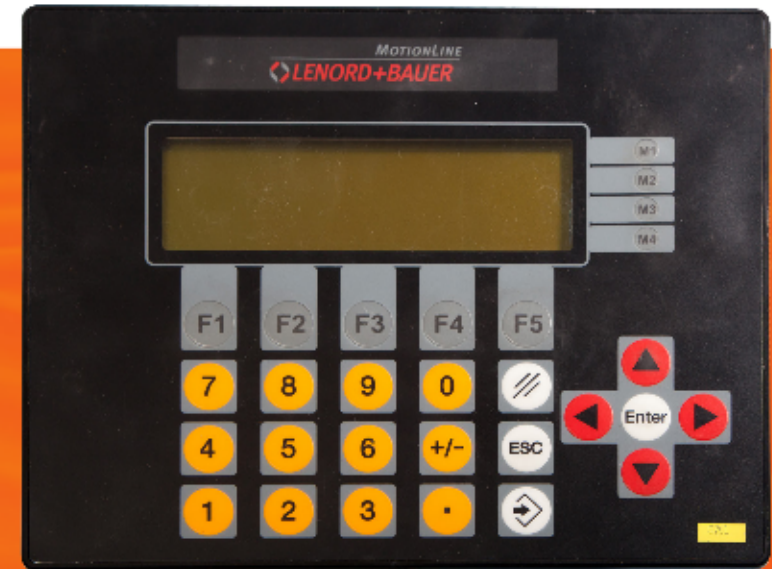
- Errors introduced under specific environmental conditions (High Humidity)
- Solutions: Conformal coating now added as standard!

- Prone to Communication and timeout, noise and transient signal issues
- Solution: Circuit Enhancements use of Military spec Opto-couplers
- Improved Protection and higher electrical power rating
